415 Village Drive  
El Cerrito, California  
May 7, 2014 - 9:00 a.m.  
Report Number 52169

This Report Prepared for  
**Jeanne Hazemoto Trust**

Inspected by Brian Rood  
Member: American Society of Home Inspectors (ASHI)

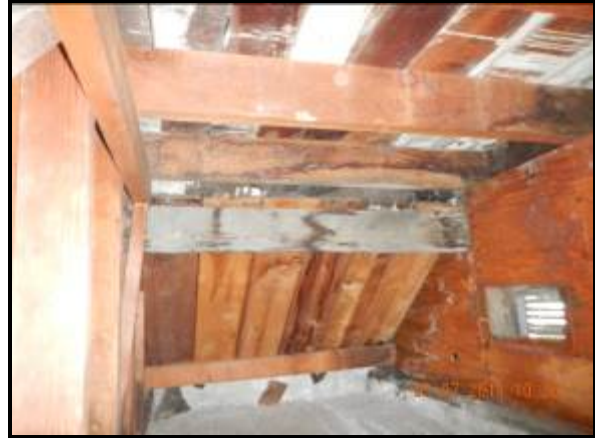
We observed stains below this area, possibly indicating membrane failure. We recommend the exposed surfaces be kept well-sealed to prevent future water entry and damage.

The concrete is supported by framing that is not decay-resistant. The proper procedure is to use pressure-treated, decay-resistant lumber in areas potentially subject to dampness, especially where in contact with masonry or concrete. We recommend the framing be monitored for damage or decay and the exterior surfaces be kept well sealed.

Stains on framing below porch

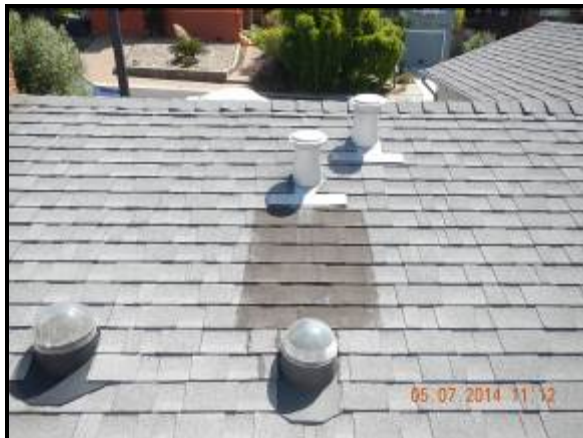
The roofing has been patched near the skylights, possibly indicating previous roof leakage and subsequent repairs. We recommend a history of patching and other roof repairs be obtained, including the name of the repair contractor and the extent of any leaks and related damage.

Patched roofing

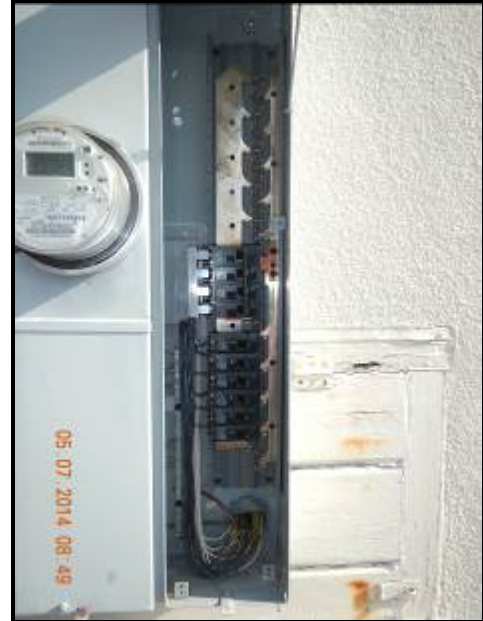
Main panel

The circuits are not protected by arc fault circuit interrupter (AFCI) breakers and we suggest they be installed by a qualified electrician to meet modern safety standards.

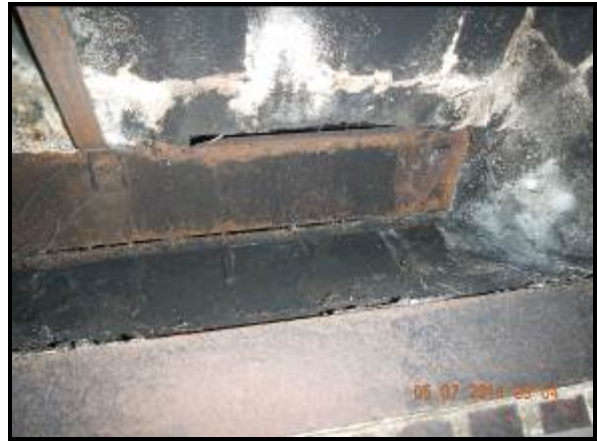
There is a masonry fireplace in the living room. The brick firebox is in generally worn condition. The mortar between the firebox bricks is soft in places. Portions of the firebox mortar are missing. We recommend the firebox be repaired by a qualified contractor.

Efflorescence and damage

We observed efflorescence in the firebox, apparently caused by moisture rising up from below or entering from the chimney above.
